FEDERAL RAILROAD ADMINISTRATION
1200 New Jersey Avenue SE, Washington, D.C. 20590

PRELIMINARY FACTUAL FINDINGS REPORT
Derailed Union Pacific's Unit Crude Oil Train ONETU 02
Transporting Bakken Crude Oil for U.S. Oil
Mosier, Oregon

June 23, 2016

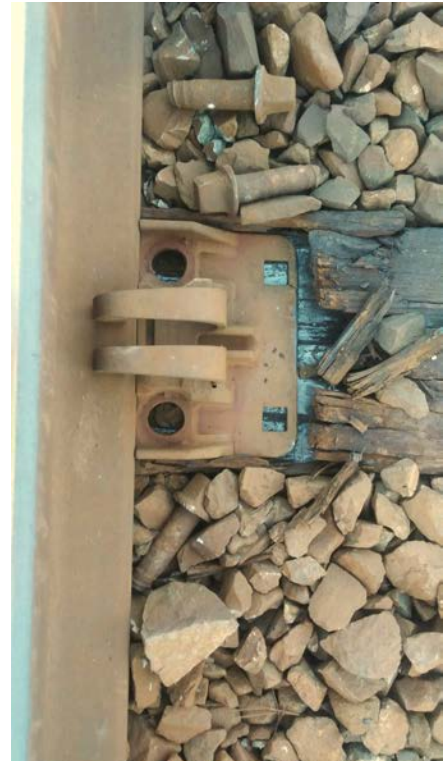
FRA's preliminary investigation determined the Union Pacific derailment was caused by broken lag bolts leading to wide track gauge.

FRA's investigation found that multiple lag bolts in this section of Union Pacific track were broken and sheared, leading to tie plates loosening from ties. The loosened tie plates allowed for the rails to be pushed outwards as trains moved across them, eventually resulting in an area of wide gauge, leading to the derailment.

Unless or until additional details come to light, FRA has made the preliminary determination that Union Pacific's failure to maintain its track and track equipment resulted in the derailment. Broken and sheared lag bolts, while difficult to detect by high-rail, are more detectable by walking inspection combined with indications of movement in the rail or track structure and/or uneven rail wear, and are critically important to resolve quickly.

Image 1:
Image of broken bolts that allowed rails to go wide, causing wide gauge.

- FRA conducted walking inspections of all the curves in the Columbia River Gorge to inspect for additional track, fastener, or bolt issues.
- FRA conducted similar inspections of BNSF track on the Washington side of the Columbia River.

- FRA conducted a data search of FRA databases for tie fastener trends across the rail industry.
- Volpe, one of the Department of Transportation's research centers, is testing the metallurgy of the broken bolts.
