# Casualty Lessons Learned Two Case Studies

# **Case Study One : Hazmat Incident Ports America Outer Harbor Terminal**

# Case Study Two : Vessel Crane Damage / Near Miss Environmental Fuel Barge Incident

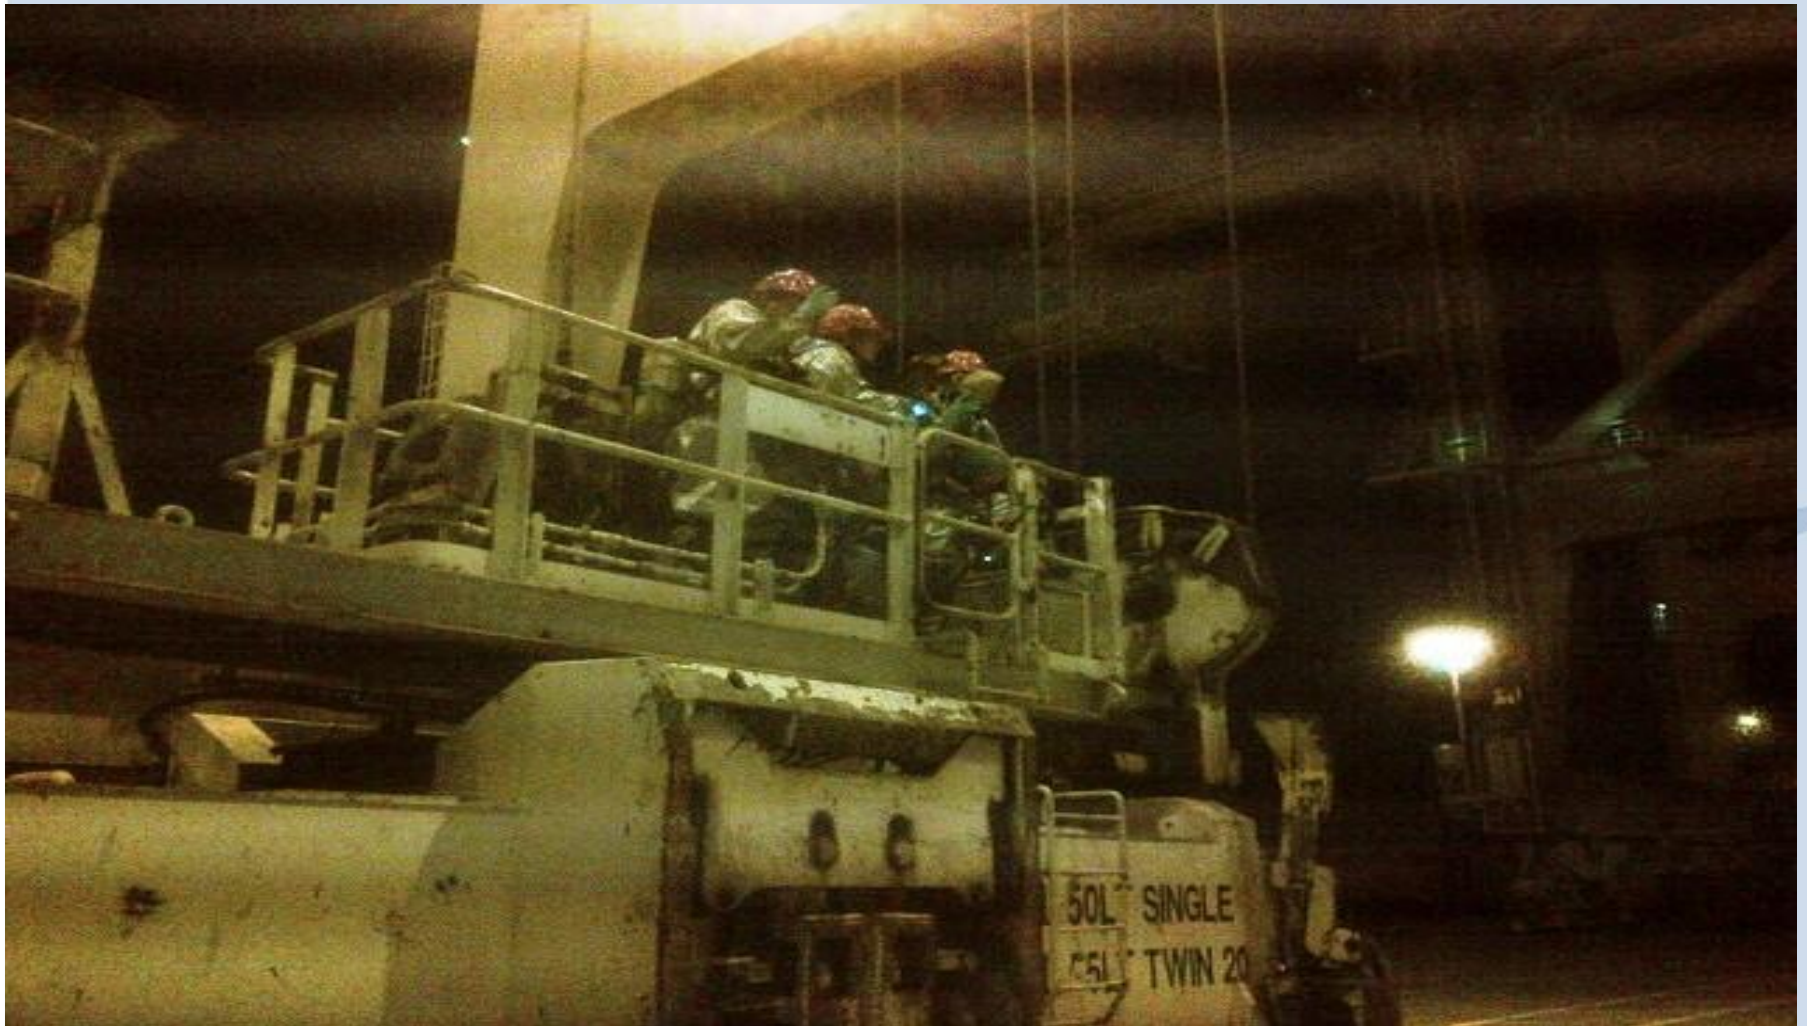
Oakland Fire Dept. on crane spreader going into the hatch for an Assessment which they passed off to the NRC team

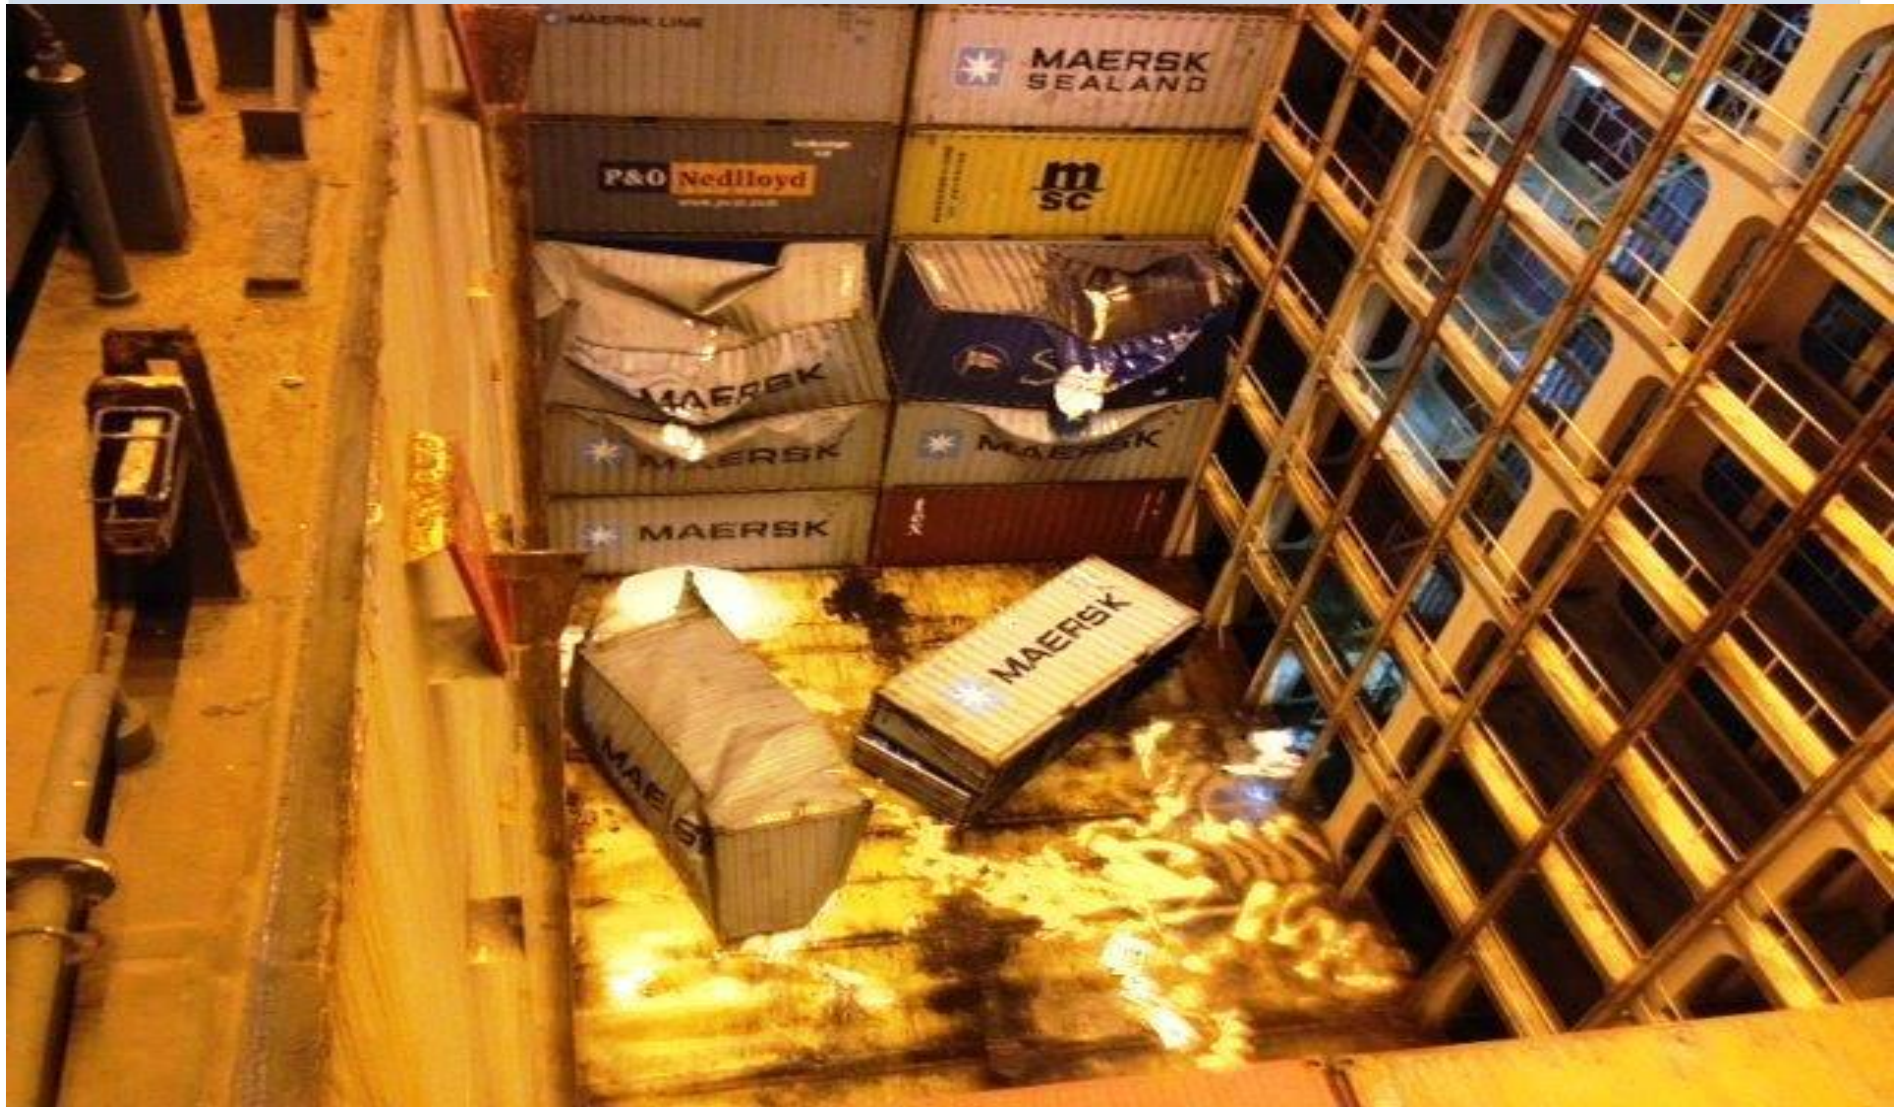
# View of the Starboard side Stow of 20' Foot Containers

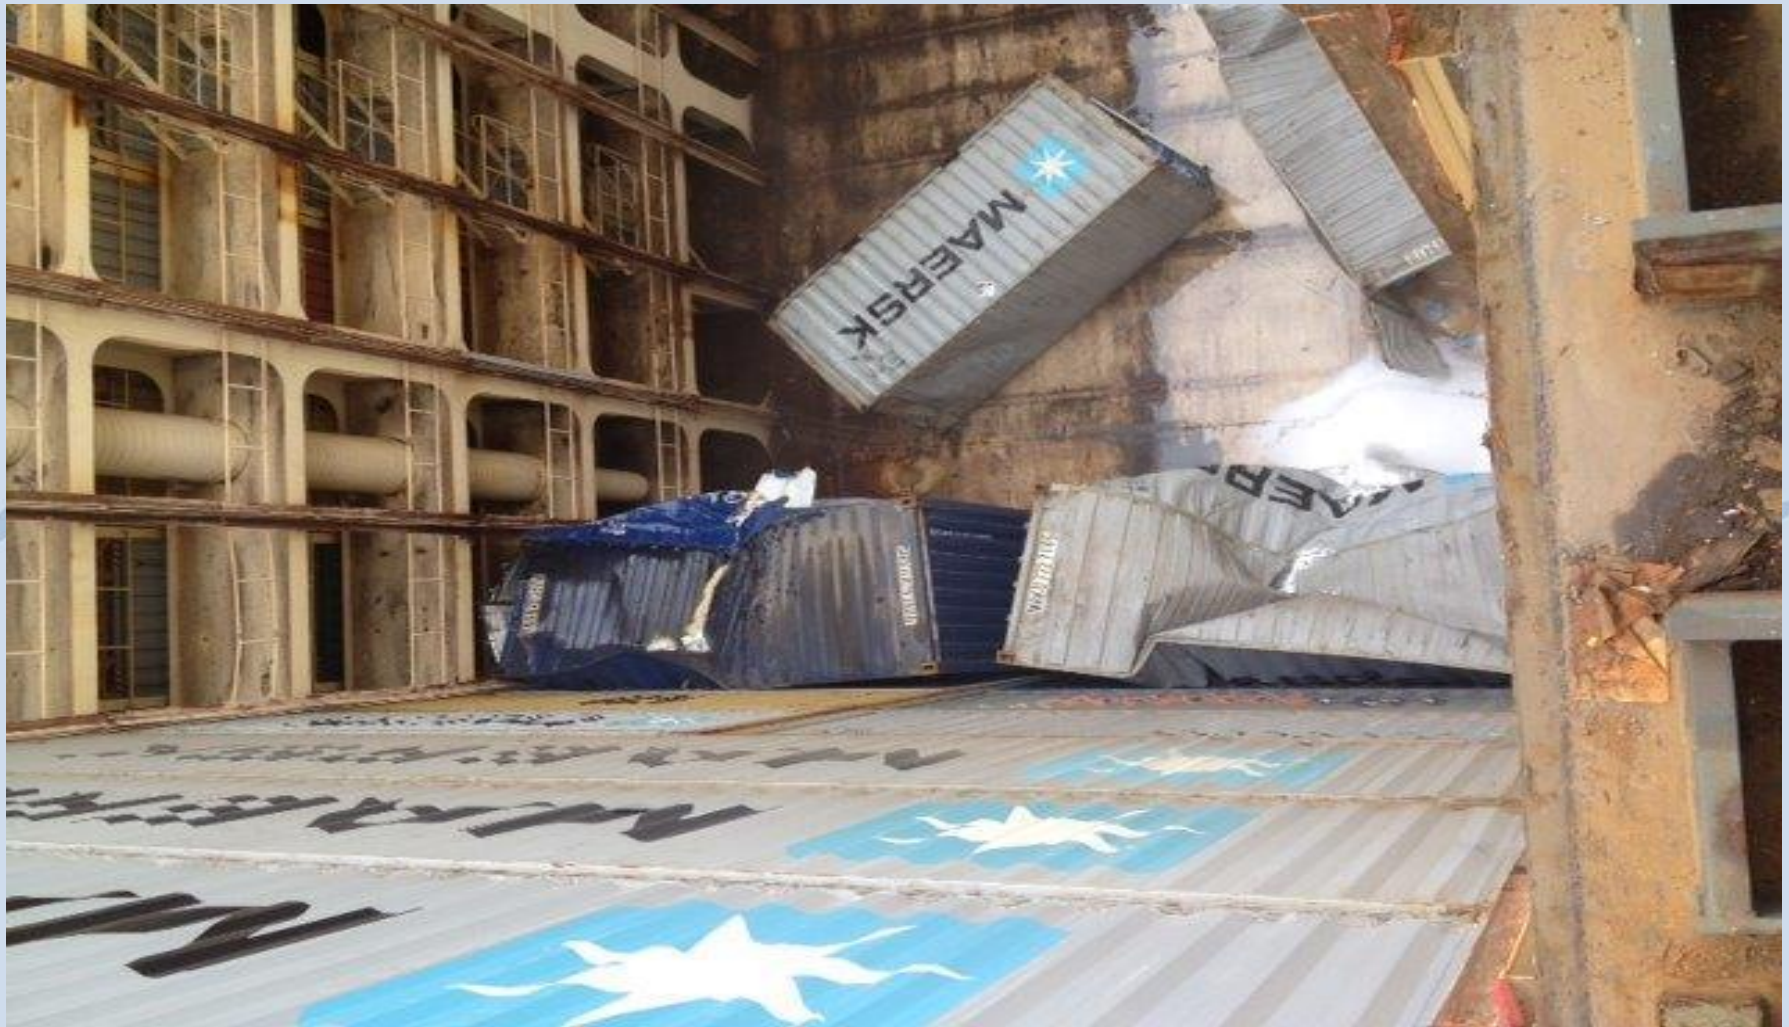
# Top view from the Starboard land side

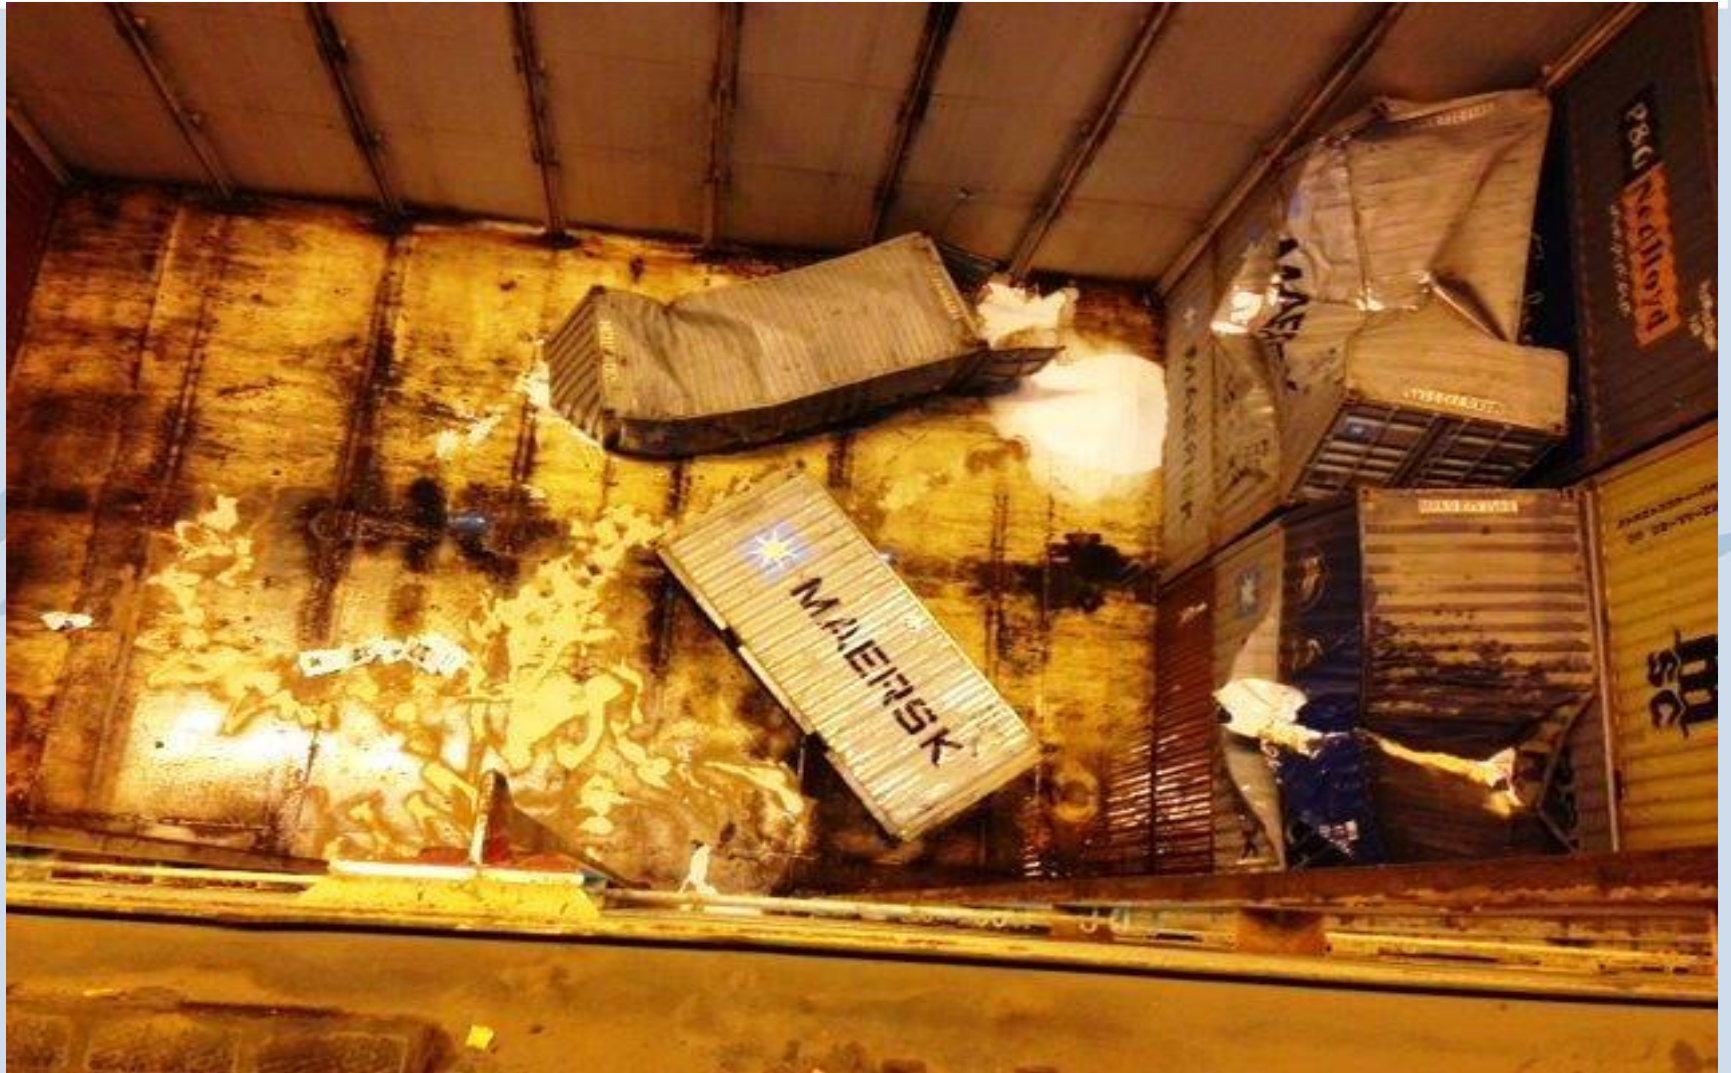
# A View of the Bay 28 looking Forward

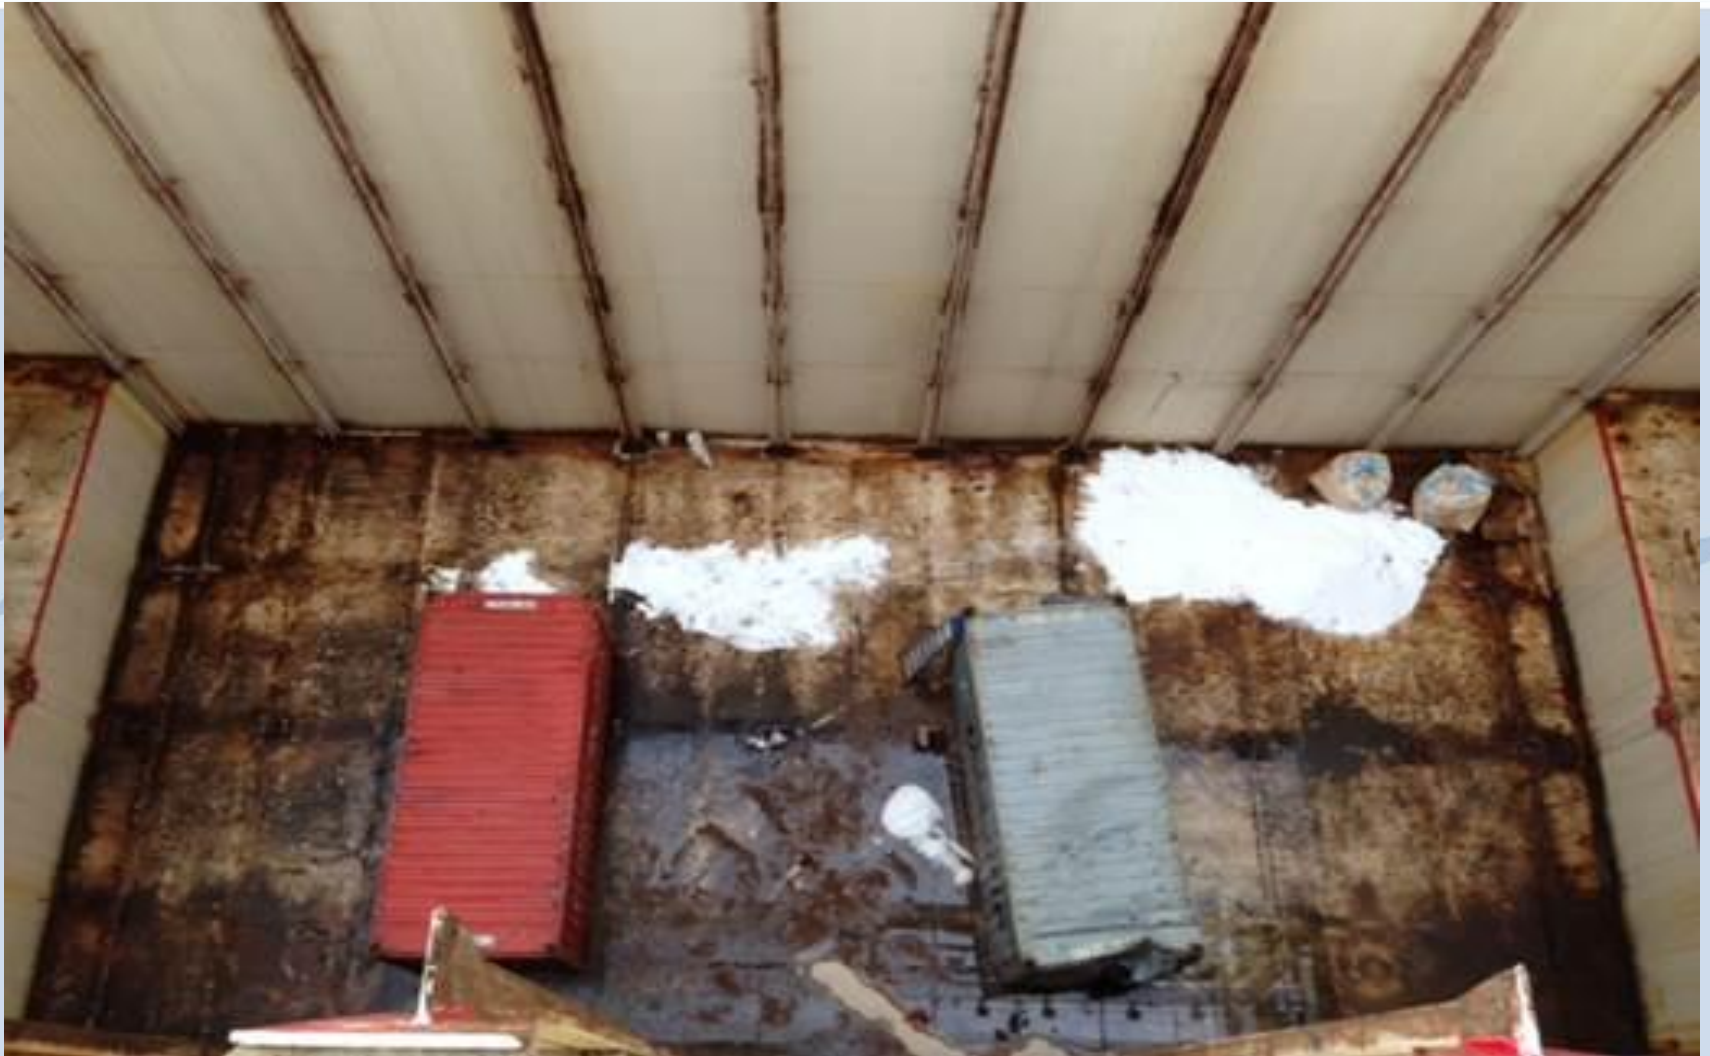
## Cargo Hold Clear of other containers - Final clean

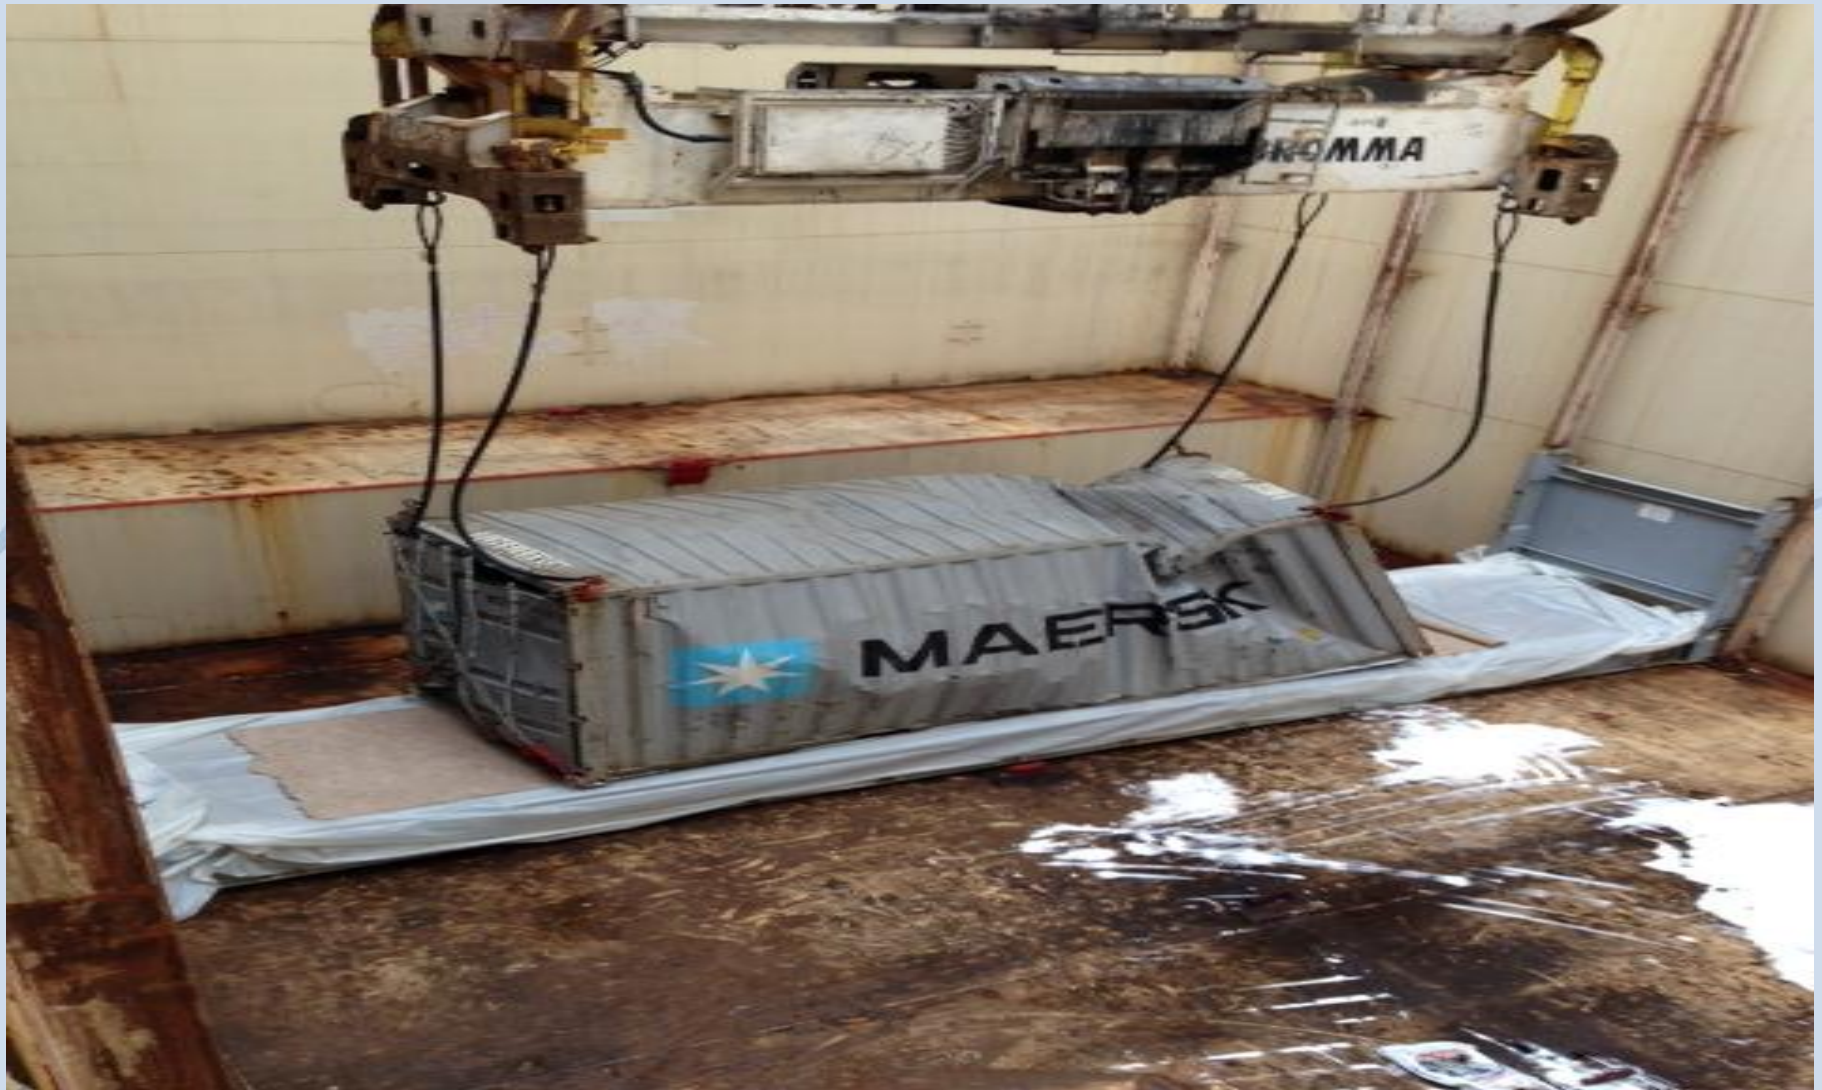
Damaged container being placed on a forty foot Flat rack for discharge to the dock stringer.

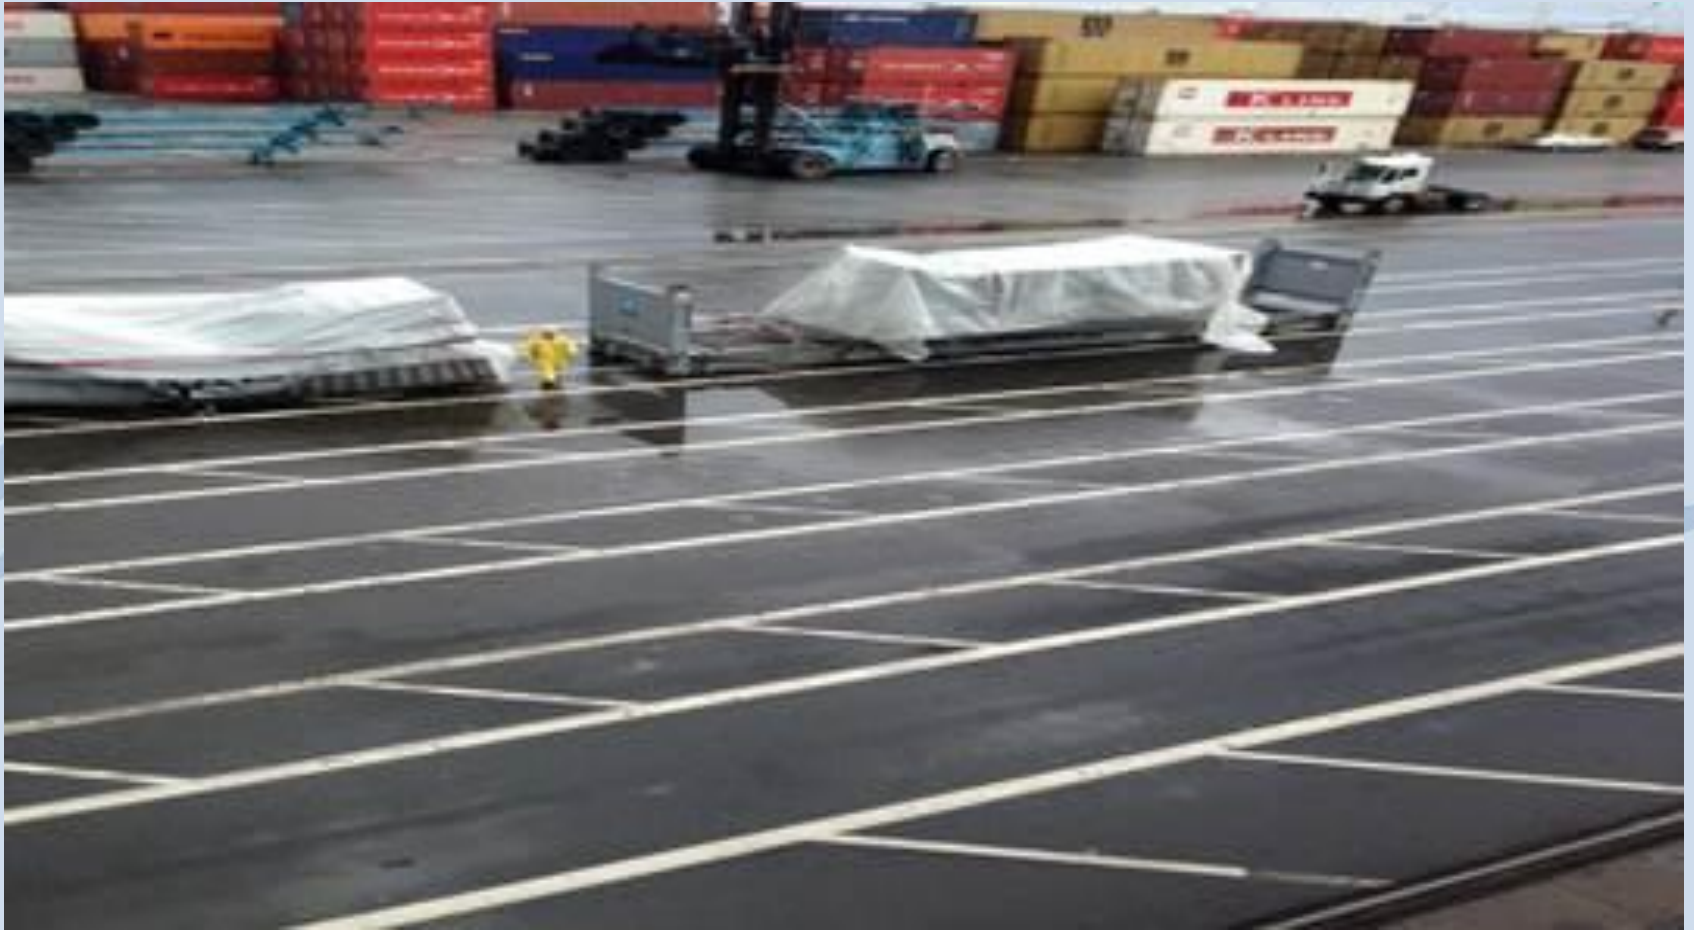
# Damaged cargo on Flat racks on the dock

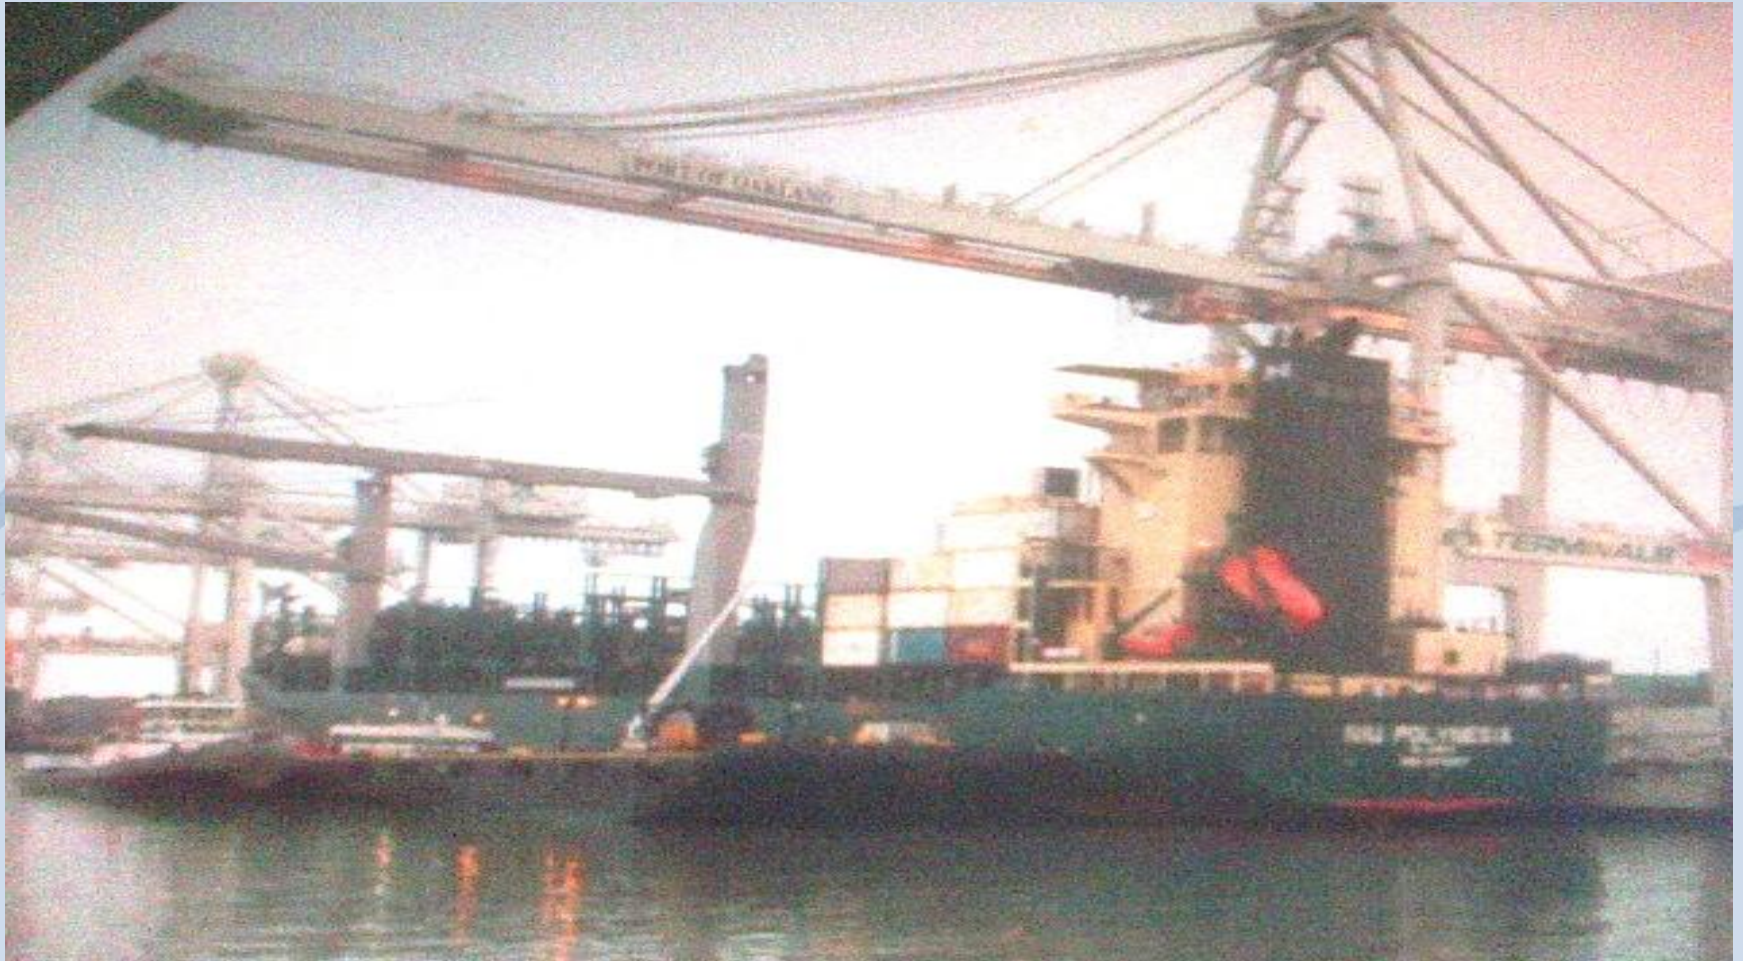
M/V Polynesia with aft # 2 boom low and over the Port side in the proper operational stow.

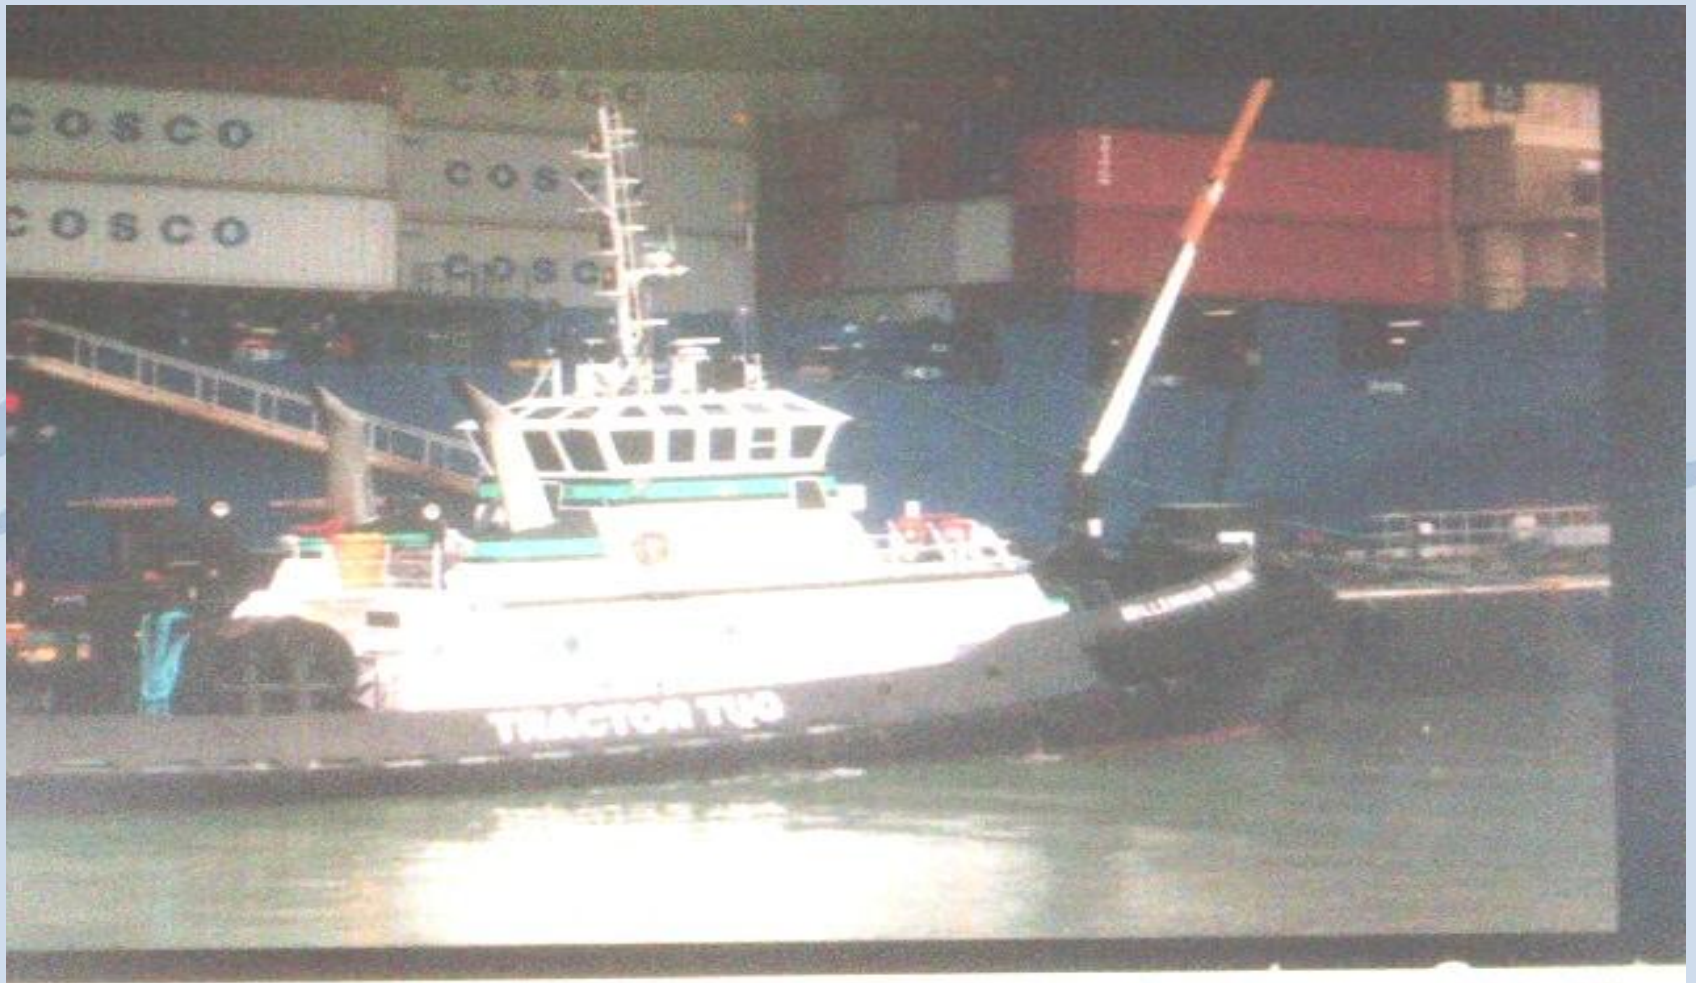
# Tug and Bunker Barge along the Port side

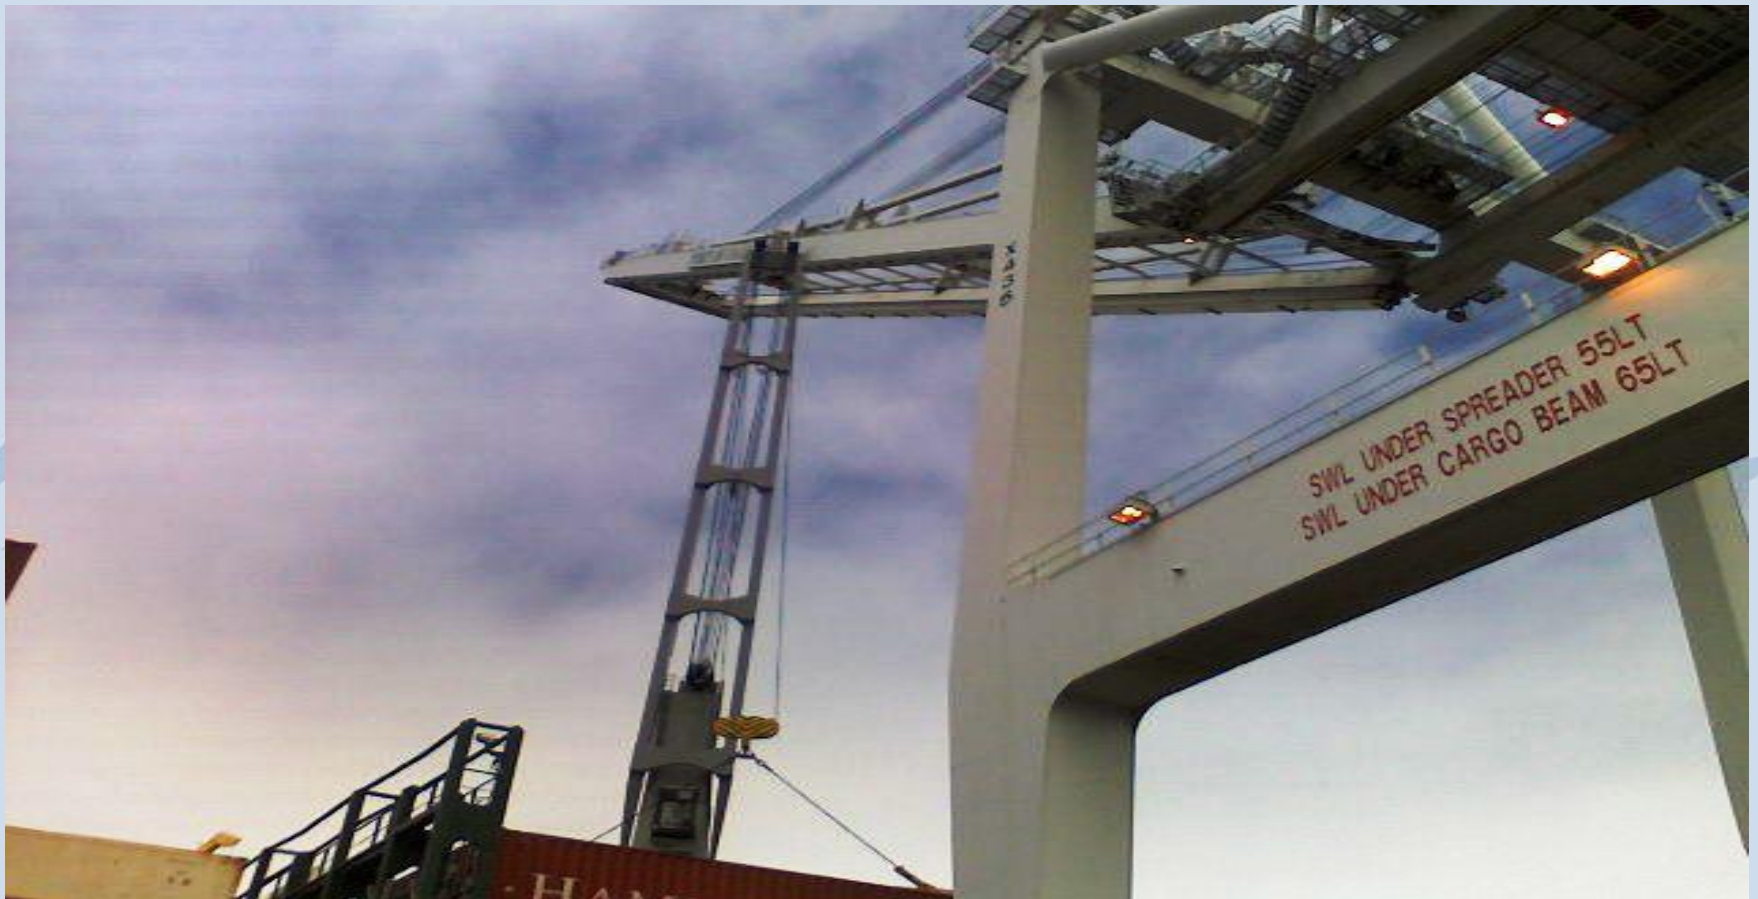
Aft ship's crane boomed up over the std'b side

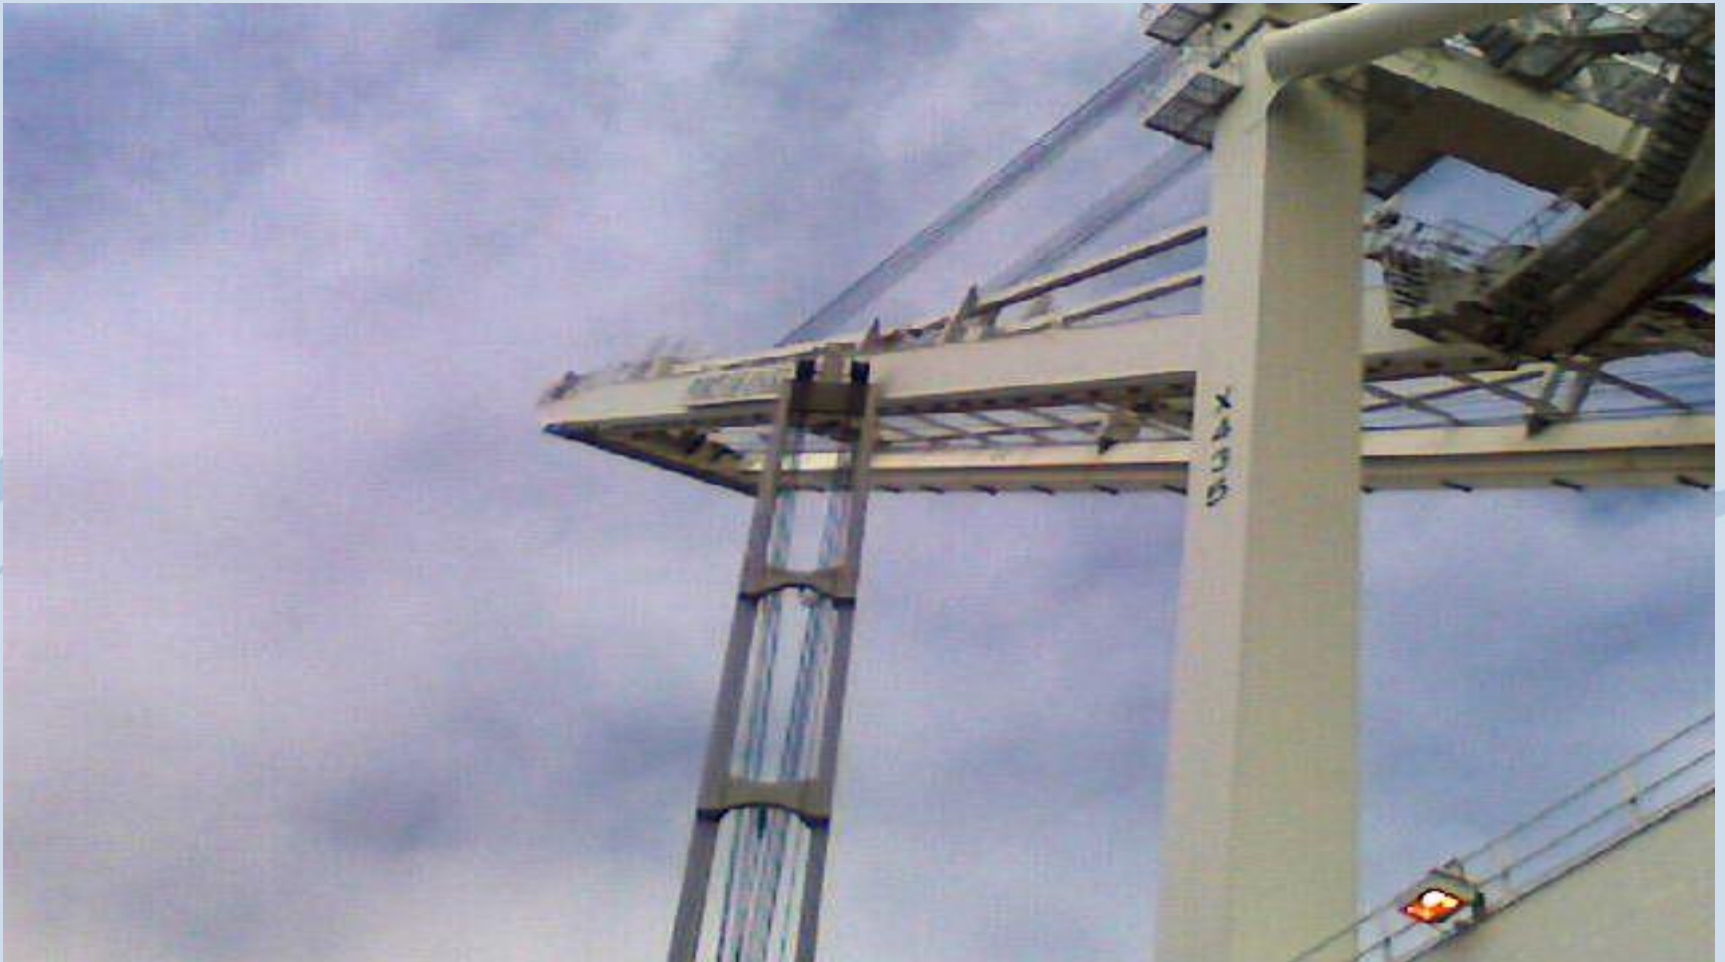
Vision of the dock Crane driver blocked by the leg of Crane 435 as he moved to a new Hatch

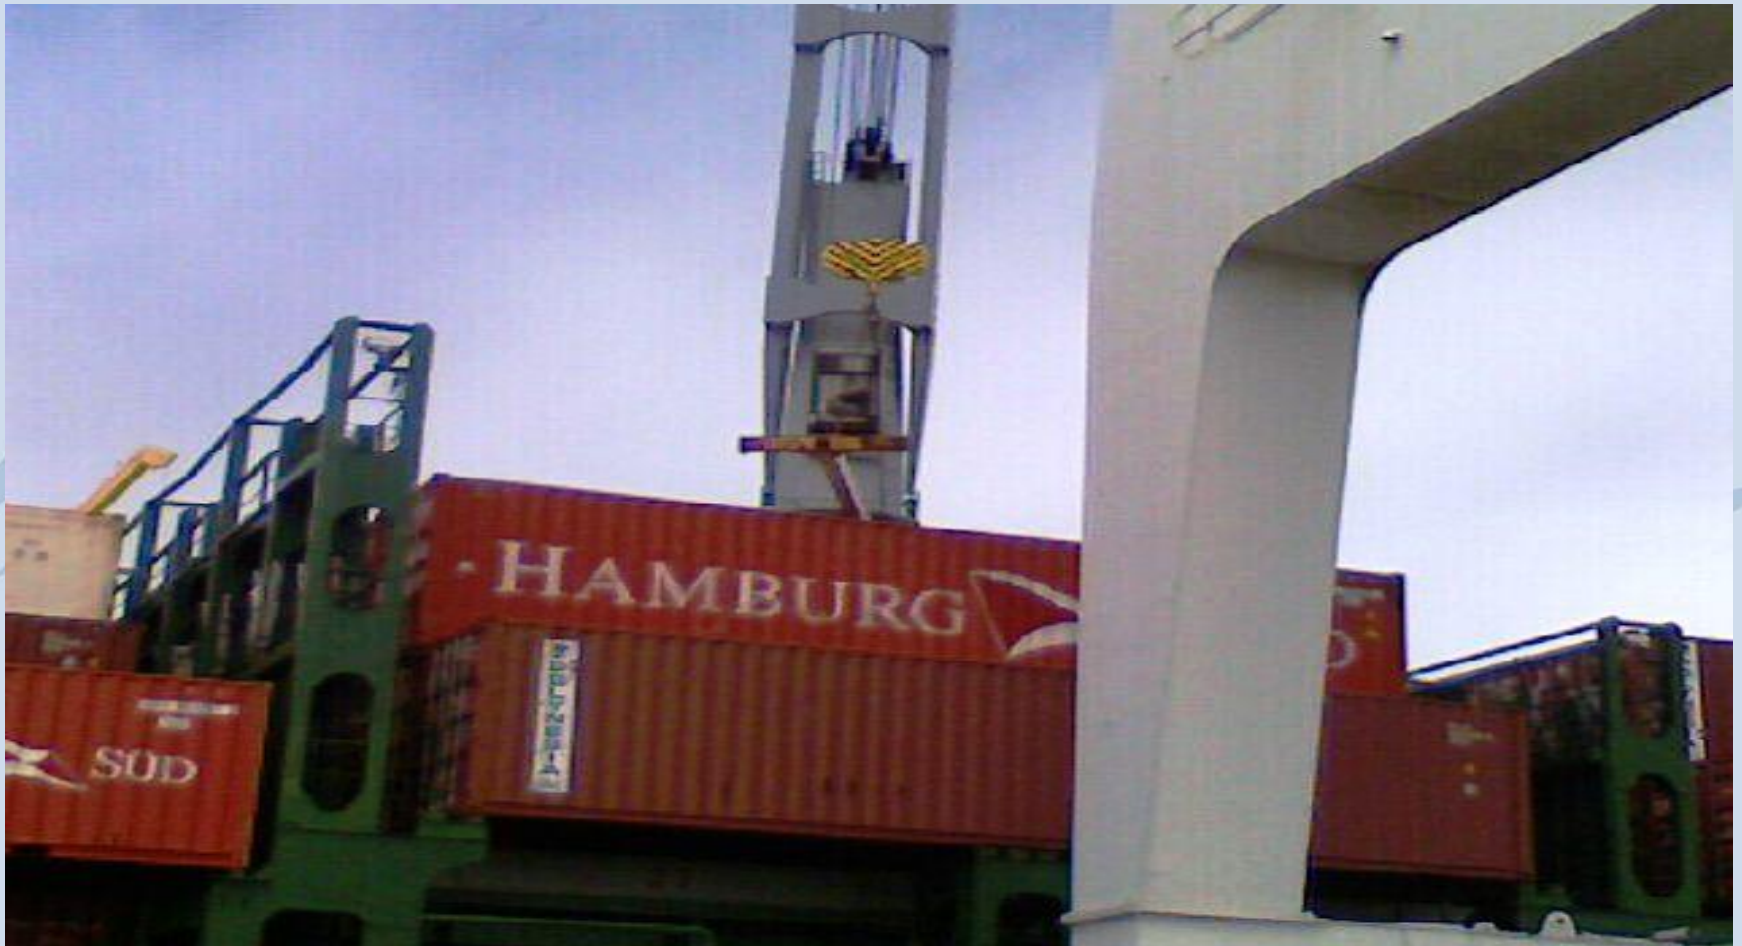
Technical problems were occurring with the ship's crane and a shore repair crew was working on the ship's crane at the time of the Incident.

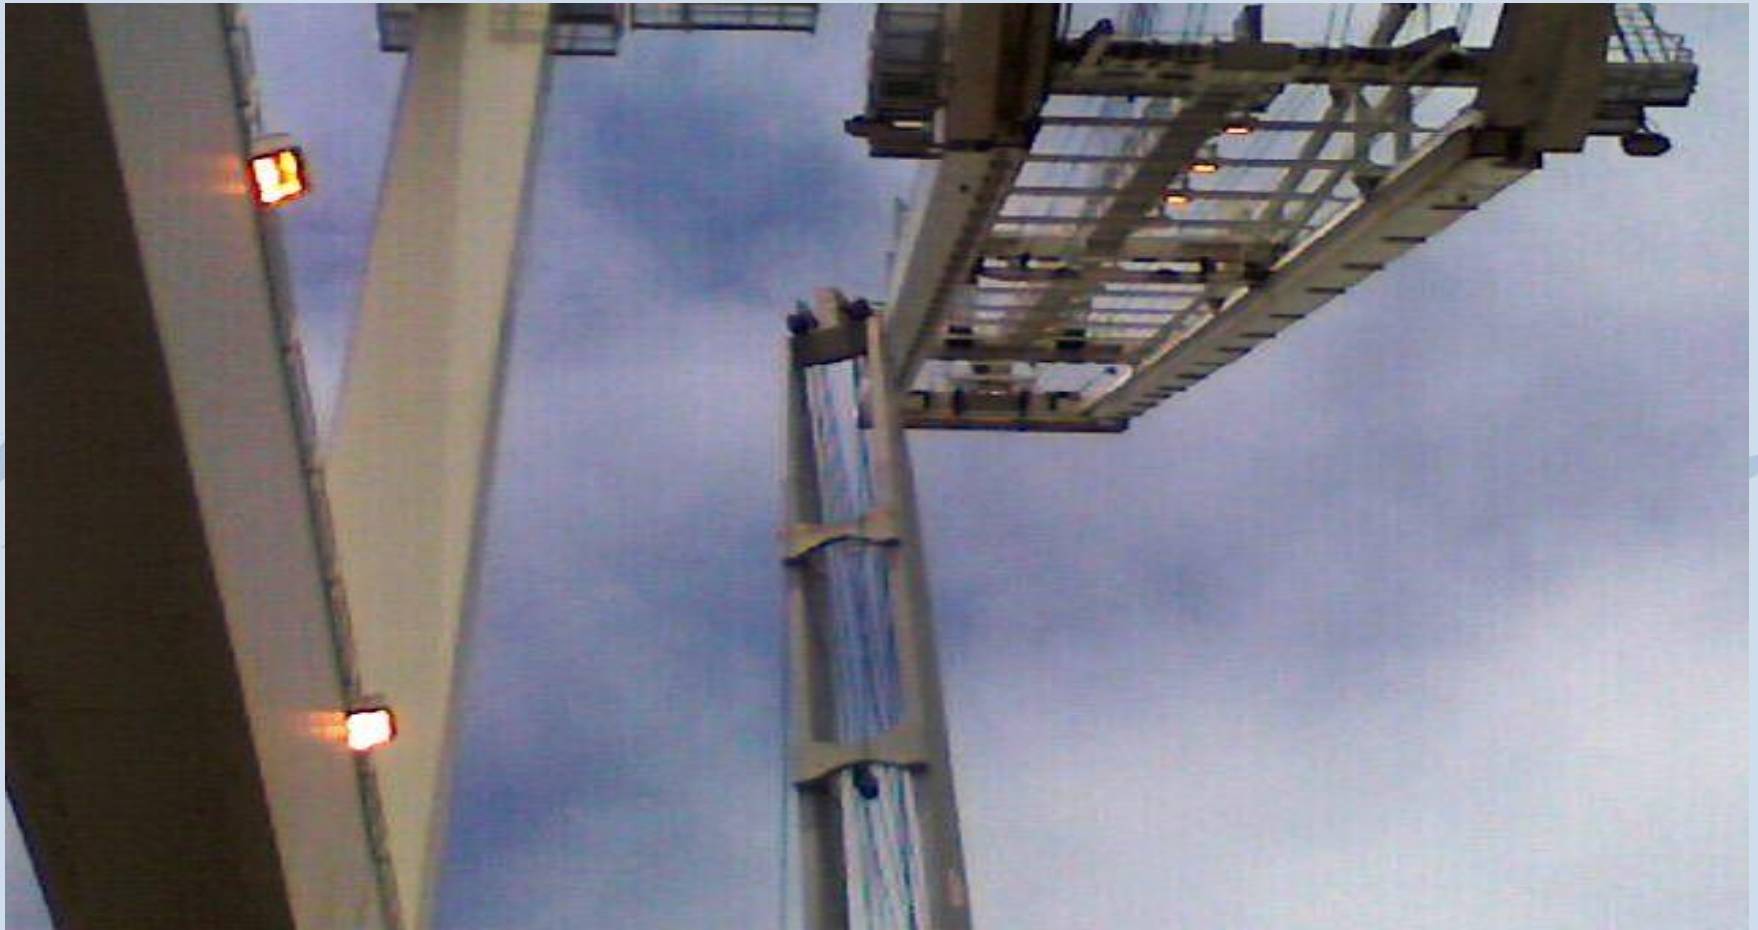
The Dock crane was in the boomed up position while gantrying aft. Collision sensors on the shore crane are not active in the boomed up position.
