# Casualty Lessons Learned Two Case Studies

# **Case Study One : Hazmat Incident Ports America Outer Harbor Terminal**

# Case Study Two : Vessel Crane Damage / Near Miss Environmental Fuel Barge Incident

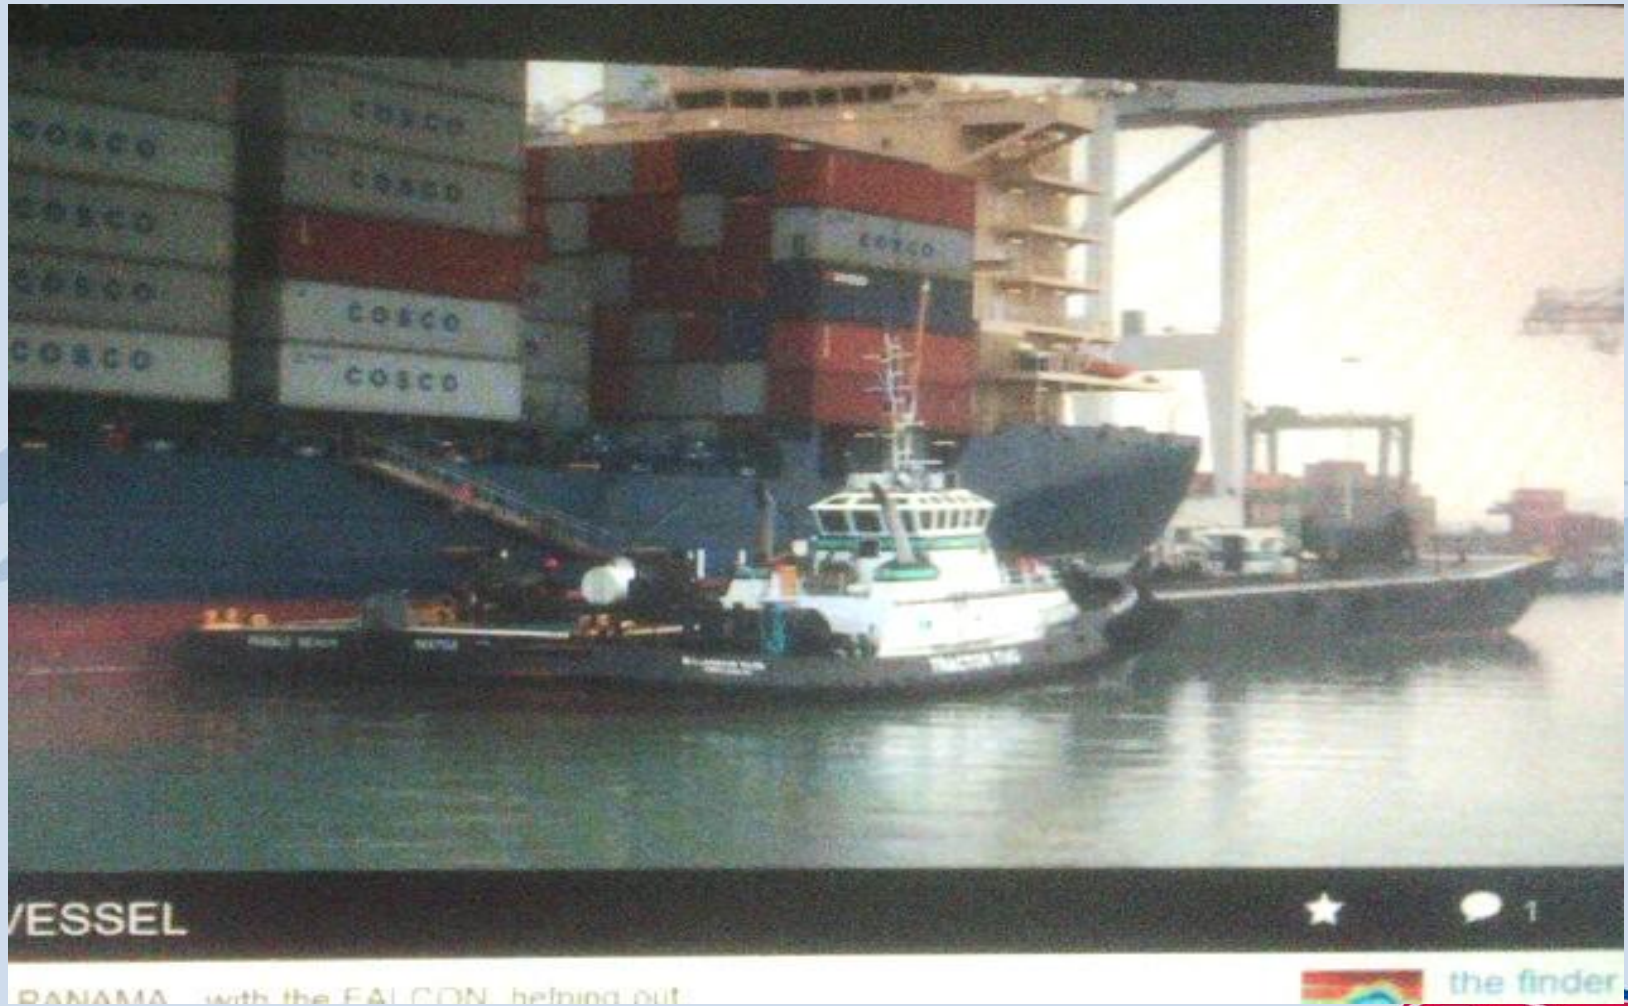
Smaller Vessels when taking Bunkers will cause the work area of the barge to extend in the cargo hatch area.

- **Bunker barge personnel have experienced objects as lashing bars, cones and recently containers falling onto the barge.**
- **Advance notification should be sent by the carrier representative/agent to the terminal that bunkering is planned for the ship while alongside.**
- **Terminal operators should incorporate the advanced notification information of bunkering into the crane letter of operation.**
- **All parties need to communicate information that would affect the safety of the bunkering operation.**
- **The walking bosses/foremen should include bunkering information into the safety talk to the longshore workforce.**
- **When and where possible, bunker barges should be secured alongside the vessel's accommodation (the house).**
